Pavement Distress: A case study of Kota-Anta road Rajasthan

Jagdish B Patel¹, Dr. L.B.Zala², Prof. A.A.Amin³

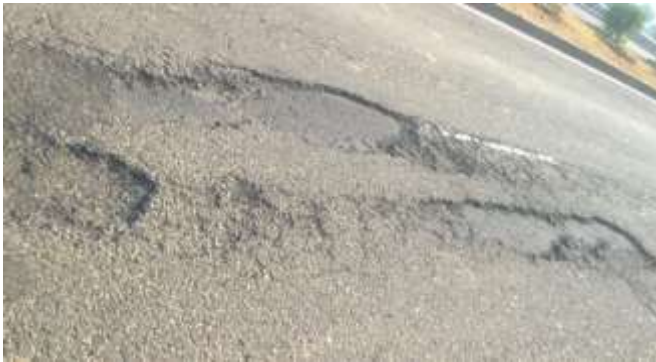
Figure-1 Pothole

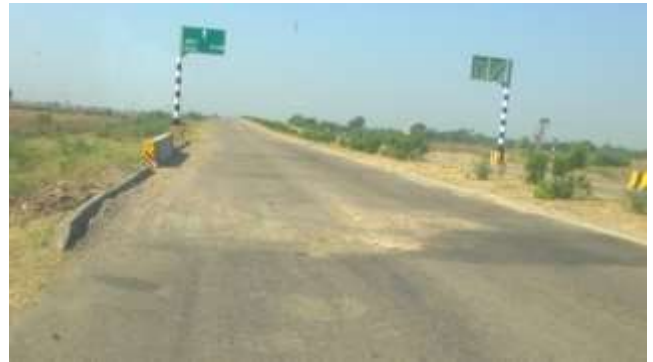
Figure-2 Patch

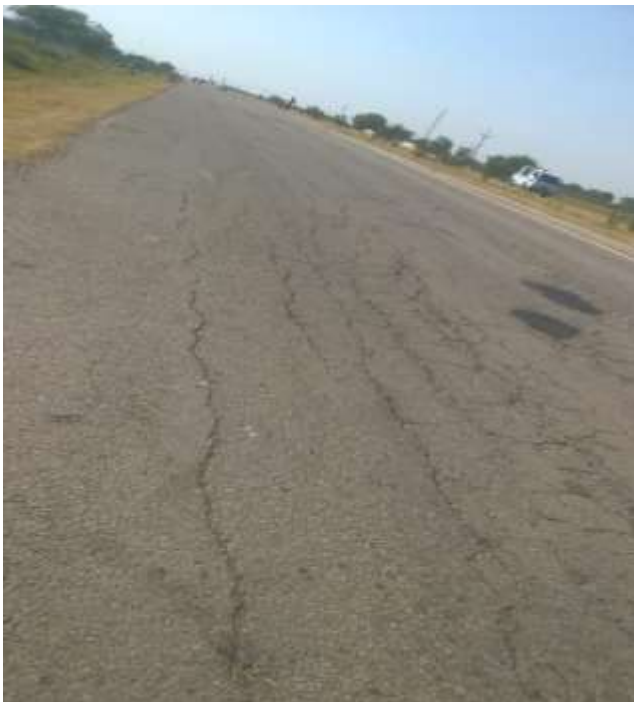
Figure-3 longitudinal crack

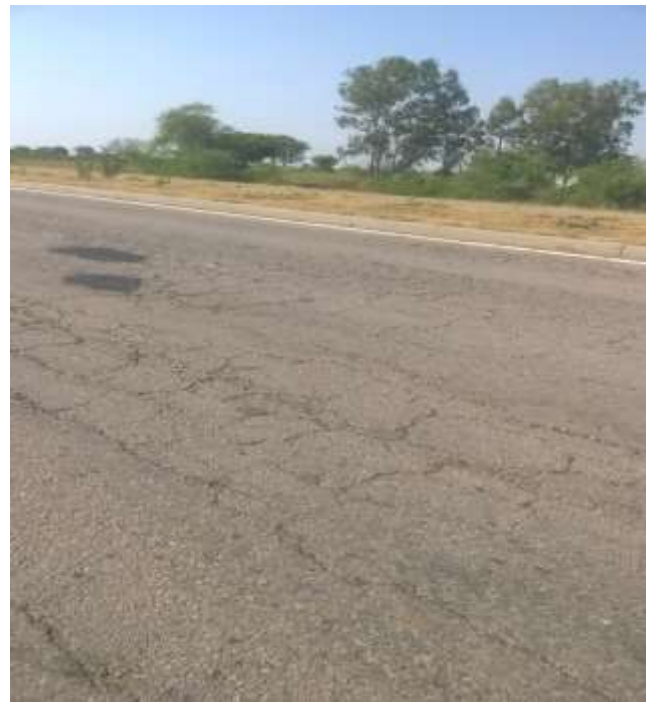
Figure-4 Alligator crack
