Pavement Distress: A case study of Kota-Anta road Rajasthan

Jagdish B Patel¹, Dr. L.B.Zala², Prof. A.A.Amin³

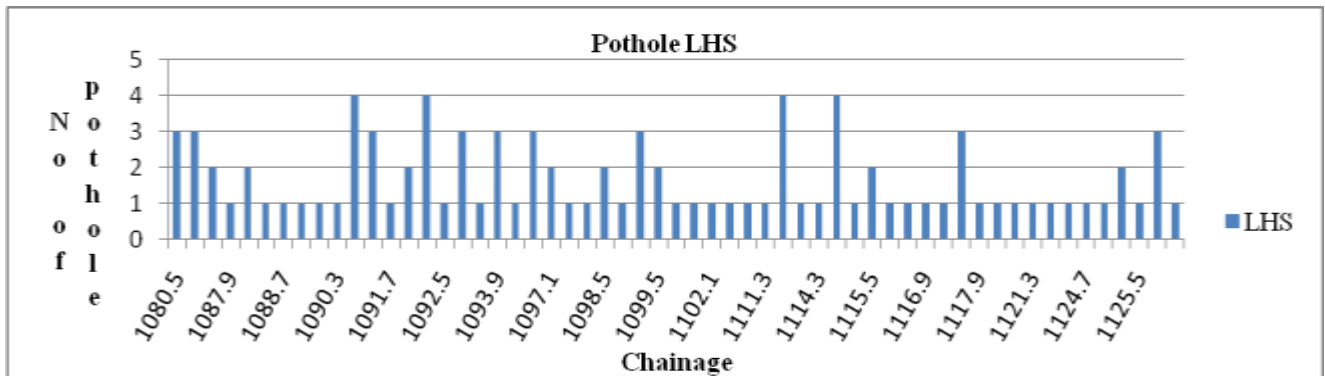
Figure-5 No. of pothole LHS

Potholes are measure by measure tap and Numbers of potholes per 200 m interval for LHS as well as RHS are as depicted in graph. Some locations have more number of potholes while some location shows good surface and having

less number of potholes. No. of potholes in LHS are more than RHS Most of potholes having area of 1sq m to 2sq m. maximum pothole is 4 and minimum pothole is 1.

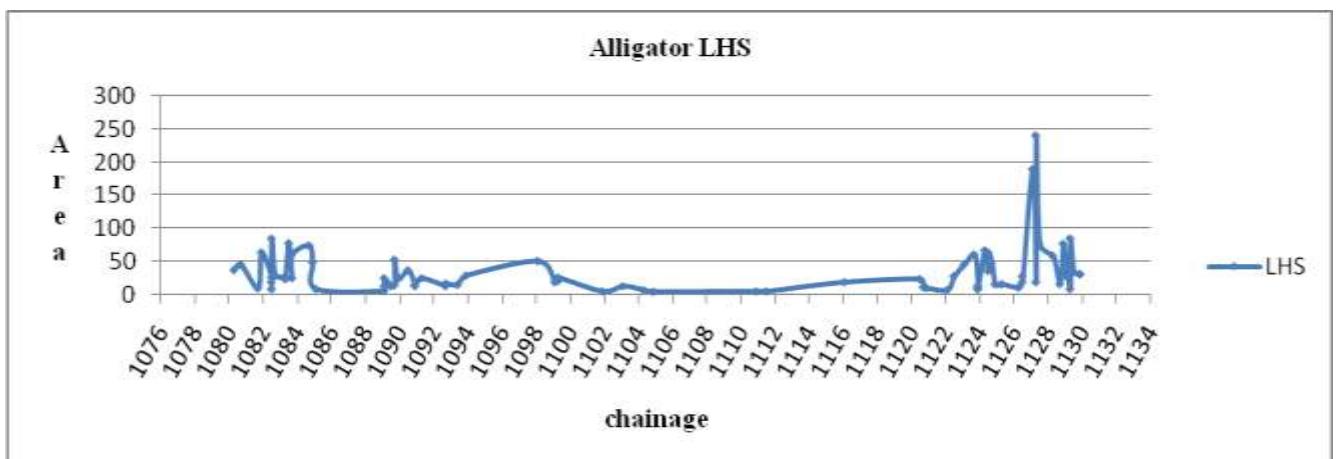
Figure-7 Area of Alligator crack LHS

Length and width of Alligator cracks are measured Area of cracks are found as % of Carriage way Study are shows excessive number of alligator cracking compare to longitudinal cracks Maximum, minimum cracking is show in graph .

The possible causes and probable treatments of the surveyed distresses are below. For repairing Alligator crack treatment are Strengthen the pavement or reconstruction, Base recycling or reconstruction, Replace or treat wearing course. For repairing longitudinal crack in treatment are Cut and patch, replace bituminous surfacing, Reconstruction of joints, Crushed aggregate overlay or reconstruction of joints. For repairing pothole treatment are Patching, Cut and patch, Base reconstruction Base reconstruction. For repairing rutting treatment are Strengthening overlay or reconstruction, Replace or recycle bituminous surfacing or use the stiffer mix, Base or sub base strengthening.

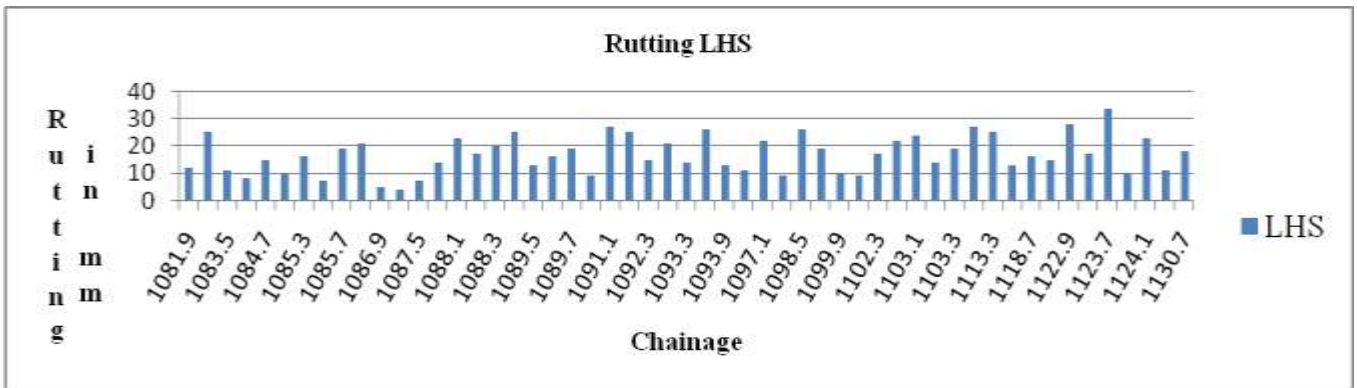
Figure-11 Rutting LHS

From the observation data collected by pavement condition survey from CH. 1080.263 to CH. 1130.000 and found the total rutting area is 3453.2 the maximum rutting is 34 at ch. 1123.6 and minimum rutting is 4 at ch. 1086.8.

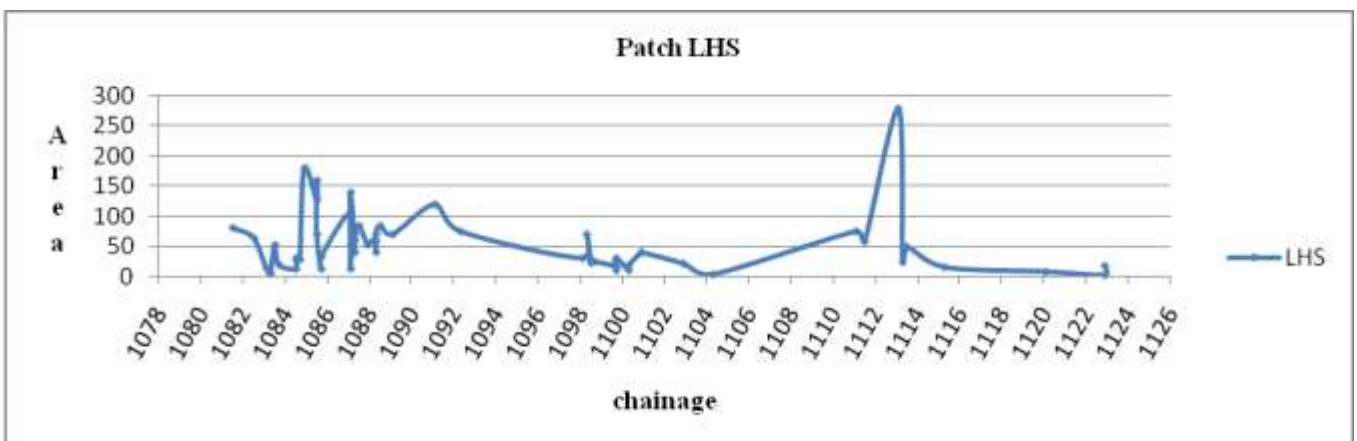
Figure-13 Patch LHS

Patches are measured in sq. meters and relevant area of carriageway is to be determined. Patchwork in LHS is more than RHS. Survey depicts that some areas are extensively good with no deterioration but some areas show a higher number of deteriorations.
